## St John in the Wilderness

In order to develop planning tools for the future of St. John in the Wilderness, the Vestry and Building Committee recommended undertaking an “existing conditions survey” of the complex. Two parishioner architects and Crawford Engineers conducted visual inspections of the Church, the Rectory and the grounds in the winter and spring of 2017.

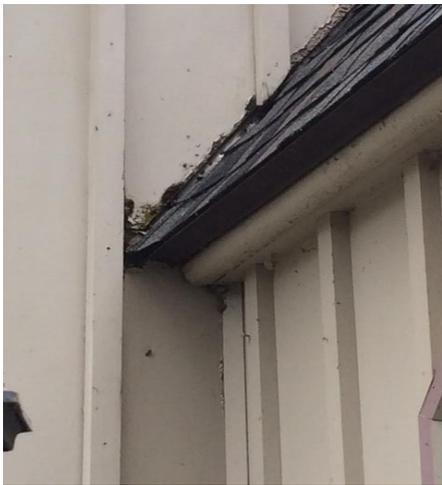
Narthex meets main building: Flashing and roofing repair needed.

1. Painting of all exterior trim (scraping and replacement as required);
2. Close survey of flashing and roofing over narthex and sacristy;
3. Replacement of sacristy exterior door and storm door;
4. New handicap access at entrance door;

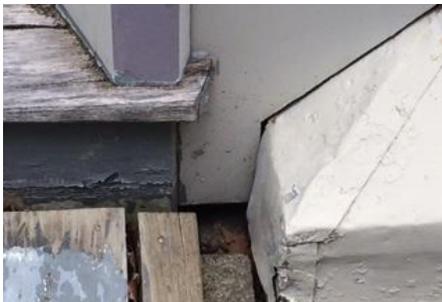
Entrance steps into Narthex. Partial repair and replacement of wood elements and flashing required.

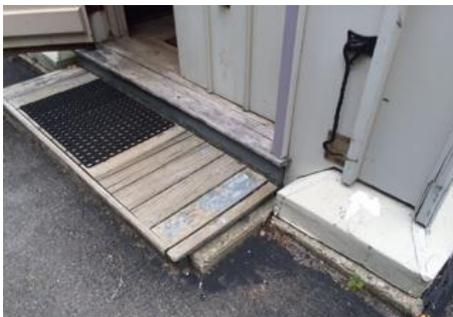
Handicap access is hampered by steps into Church. While a removable metal ramp is available, a permanent solution should be studied. One option is to build a ramp in front of the Church, which would require changes to the parking and driving areas; another is to introduce a new side door into the narthex, with ramp along the side of the church. This would also allow for an automatic door opening feature.

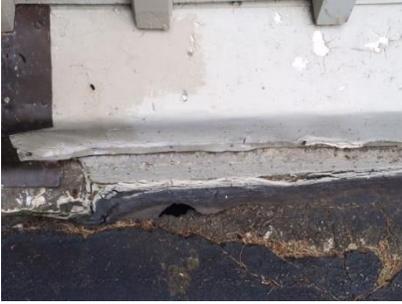
Around the Church, deteriorated flashing meets the foundations at grade. Observation of water penetration – due to rain and melted snow—at the whole perimeter of the church. Consideration should be given to this condition, including:

1. Asphalt removal all around the church;
2. regrading as required (French drainage at some locations to be identified);
3. new landscaping enhancing water retention;
4. relocation of most of the parking away from the church.

1. Removal of asphalt surrounding perimeter of the Church; regrading to divert rain water -- from upper level next to cemetery and area next to the rectory -- from entering Church basement; introduction of landscaping enhancing water retention.
2. At South of Church, replacement of railroad-tie barrier between current parking and steep slope; removal of obsolete poles and debris; striping of handicap parking;
3. New parking area at mid level flat area between entrance road and church complex, with only limited handicap parking adjacent to the church;
4. Regrading as required to divert rain water -- from upper level next to cemetery and area next to the rectory -- from entering Church basement;
5. Repainting of cast-iron fence at cemetery.

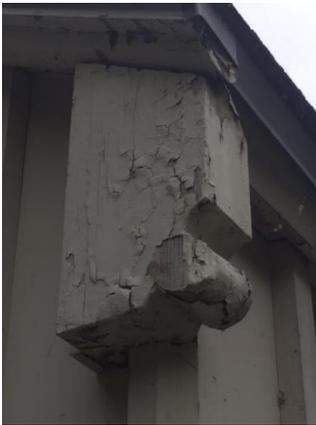
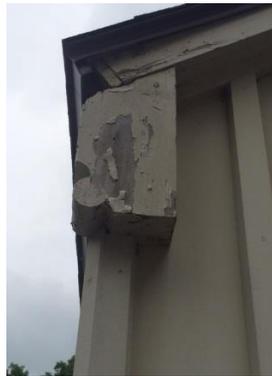
The upper surround of the Church exterior walls need repair, partial replacement, scraping and painting.

Many doors and window trim areas need to be scraped and repainted. The sacristy door needs to be replaced.
