## St John in the Wilderness

In order to develop planning tools for the future of St. John in the Wilderness, the Vestry and Building Committee recommended undertaking an “existing conditions survey” of the complex. Two parishioner architects and Crawford Engineers conducted visual inspections of the Church, the Rectory and the grounds in the winter and spring of 2017.

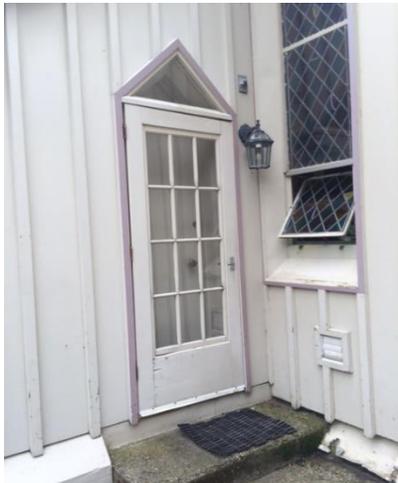
The upper surround of the Church exterior walls need repair, partial replacement, scraping and painting.

Many doors and window trim areas need to be scraped and repainted. The sacristy door needs to be replaced.

1. Painting of all exterior trim (scraping and replacement as required);
2. Close survey of flashing and roofing over narthex and sacristy;
3. Replacement of sacristy exterior door and storm door;
4. New handicap access at entrance door;
